HEAT SOAK TESTING

This Tech Talk provides information on how to reduce the risk of nickel sulfide inclusion breakage of tempered glass, using alternative heat-treating methods and heat soaking.

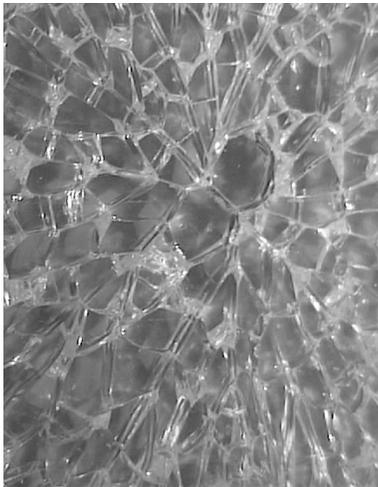
Tempered glass break pattern

Tempered glass may break without warning due to the expansion of nickel sulfide inclusions (NiS) present within float glass. To avoid the risk of spontaneous glass breakage in fully tempered glass, a common practice is to avoid the use of tempered glass whenever possible.

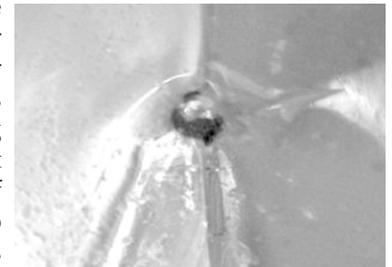
Nickel sulfide inclusion – .006219"

ASTM C 1036 generally refers to undissolved particles as gaseous inclusions, knots, dirt and stones. As stated previously, some of these inclusions may cause glass breakage. The most notorious of course, being nickel sulfide. Nickel sulfide inclusions are formed when minute nickel-rich particulates combine with sulfur in the furnace fuels or other glass batch materials. Since these inclusion tend to be less than 1/64" (0.4mm) in diameter, they are impossible to totally eliminate and all glass has some present.

When glass is heat treated, these nickel sulphide inclusions undergo a phase change as a function of time and temperature. If located near the central tension core of the glass, the expansion of these inclusions may provide sufficient stresses to produce spontaneous breakage. The inclusion expands at a rate greater than the glass and literally causes the glass to break from within.
